Navajo Abandoned Uranium Mine Site Screen Report

Kermac No. 10

Navajo AUM Eastern Region

May 2009

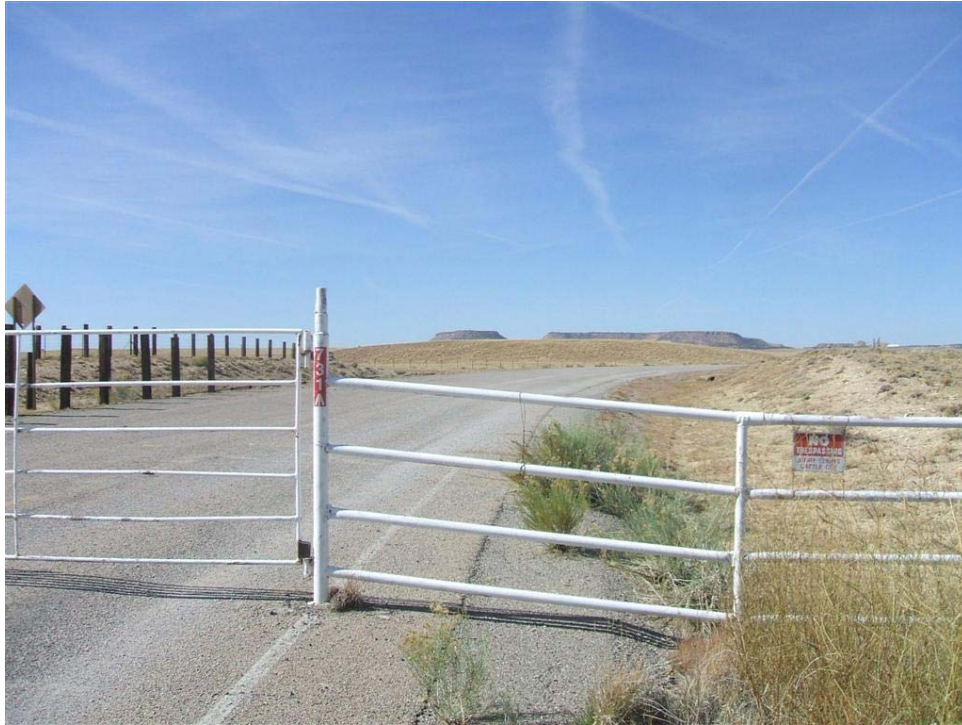
Photo 1. Locked gate on road leading towards Kermac No. 10 mine site

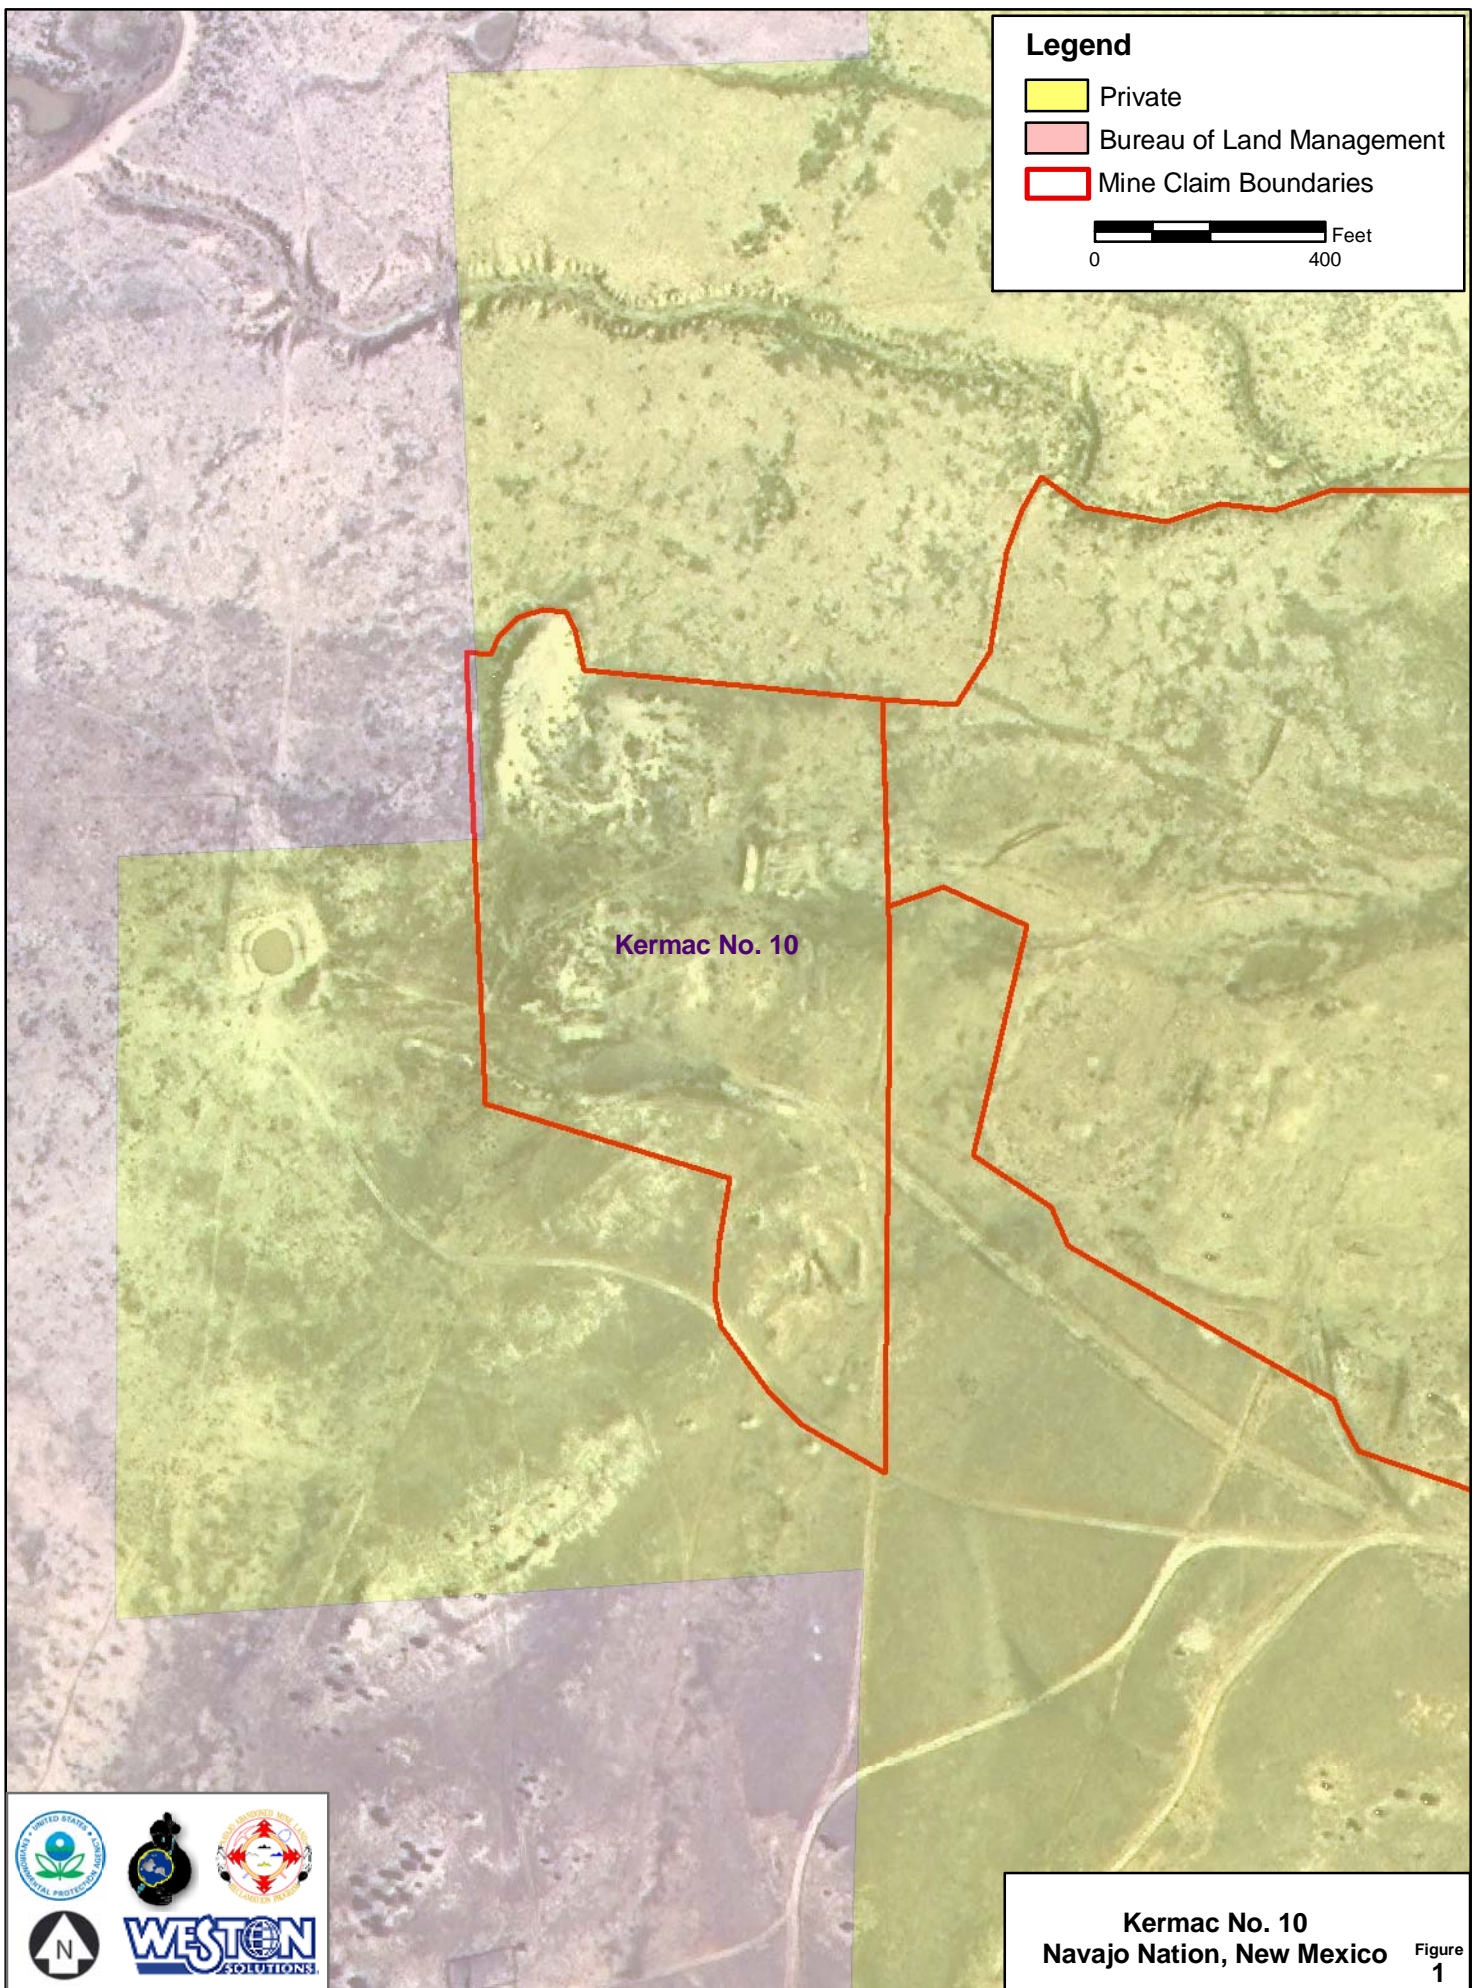
Mine site: Kermac No. 10
- See Figure 1

Presented in Figure 1
